# East Fork Jemez River

## *Stream Inventory Report*

Santa Fe National Forest  
Jemez Ranger District  
Surveyed July to September 2001  
Forest Fisheries Crew

Santa Fe National Forest  
March 2002

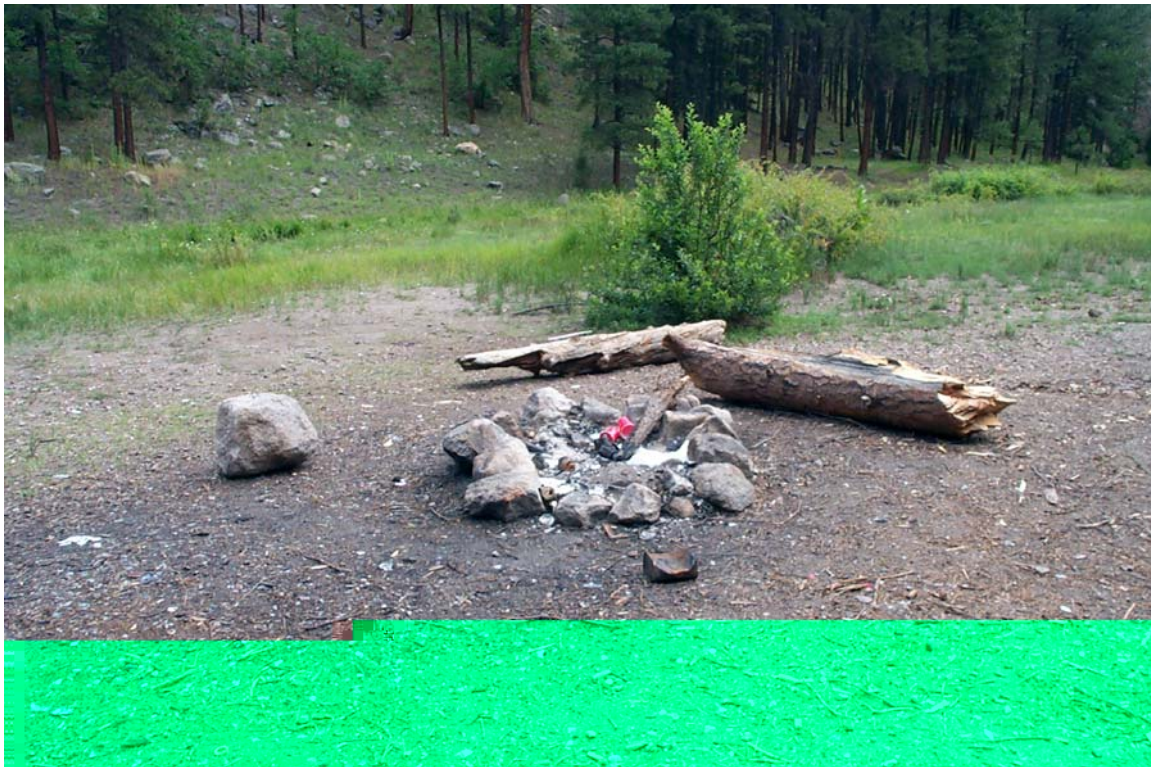
The riparian area throughout the East Fork Jemez River has received numerous disturbances. In Reaches 1, 3, 4, and 6 the main disturbances have been from recreational activities. In all of these reaches, there are trails near the river. This has led to the trampling of riparian species near the trail and the widening of the stream at trail crossings. There are many dispersed campsites along these trails that have increased the soil compaction and removal of vegetative species altogether. The report “An Analysis of the Riparian Zone Along the East Fork of the Jemez River” (Marron Taschek Knight, INC., 1991), states that these same disturbances were occurring in 1991. The report also stated that on the East Fork Jemez River (from the Baca Ranch boundary to the mouth at Battleship Rock) human recreation was the most degrading disturbance and that cattle grazing had very little impact on the riparian vegetation.

**Photo 2.** Reach 4, NSO 241, P112. Campsite along the East Fork

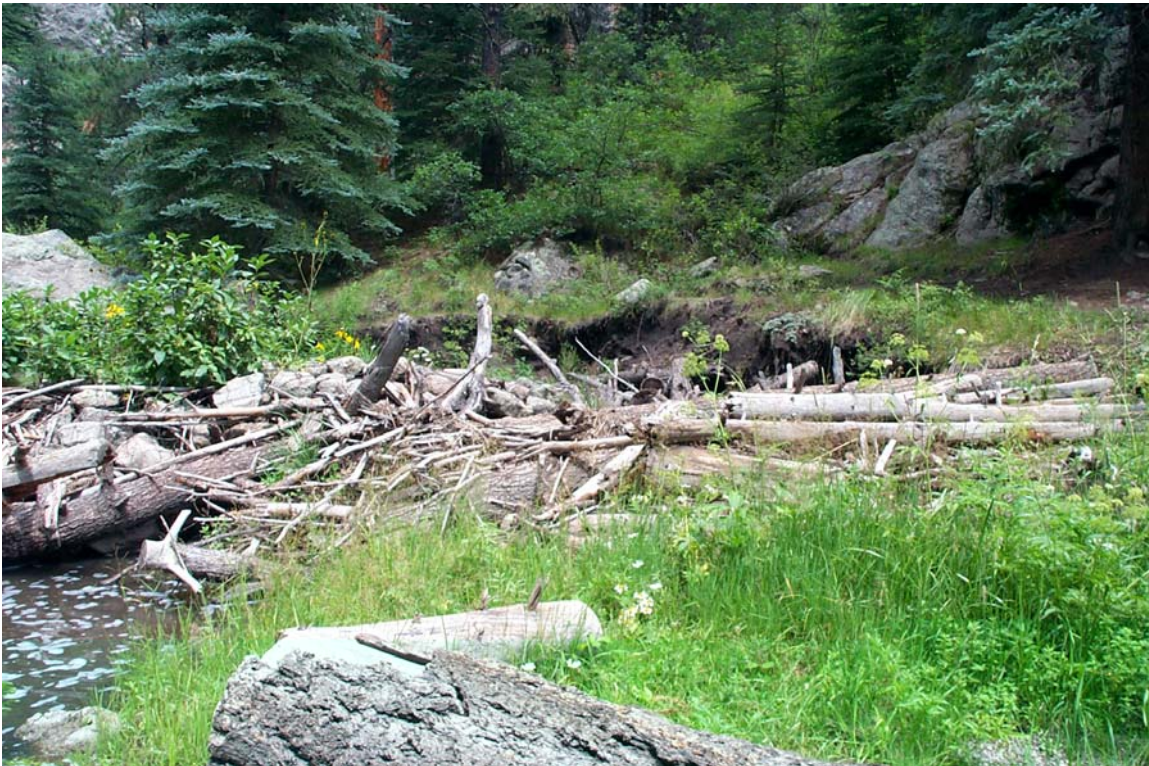
**Photo 4.** Reach 6, NSO 430, R174. Gabion that is increasing bank erosion. LWD has been placed in front of the gabion to prevent further bank erosion.

East Fork Jemez River is definitely a candidate for LWD placements. However, in order for these projects to work, they must be done correctly. First, the area that is most devoid of LWD is Reaches 6-8. However, Reaches 7 and 8 are on the Valle Grande. Valle Grande is a low gradient meadow system defined by grass banks. There was no source for woody recruitment on Valle Grande. However, once you proceed downstream of Valle Grande into the “Hidden Valley” section of the VCNP, the stream passes through small conifer stands. These areas were possibly full of aspen at one time, but with historic land management practices, these stands have disappeared. It was areas like these that would make ideal beaver habitat, and eventually excellent RGCT habitat.

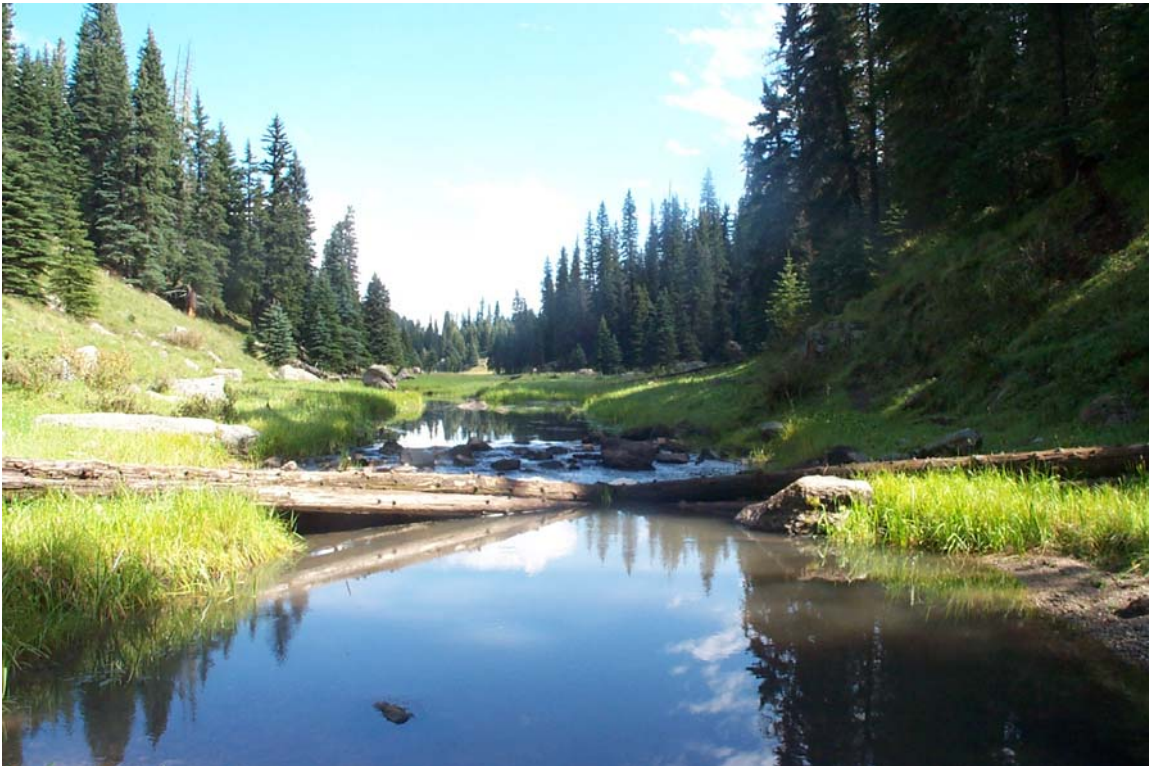
**Photo 5.** Reach 6, NSO, 492 R199. Old stream improvement project. These 6 pieces of wood were placed into the stream in an upstream direction forming a “V”. The structure has increased scour underneath the structure and widened the stream upstream of the structure.

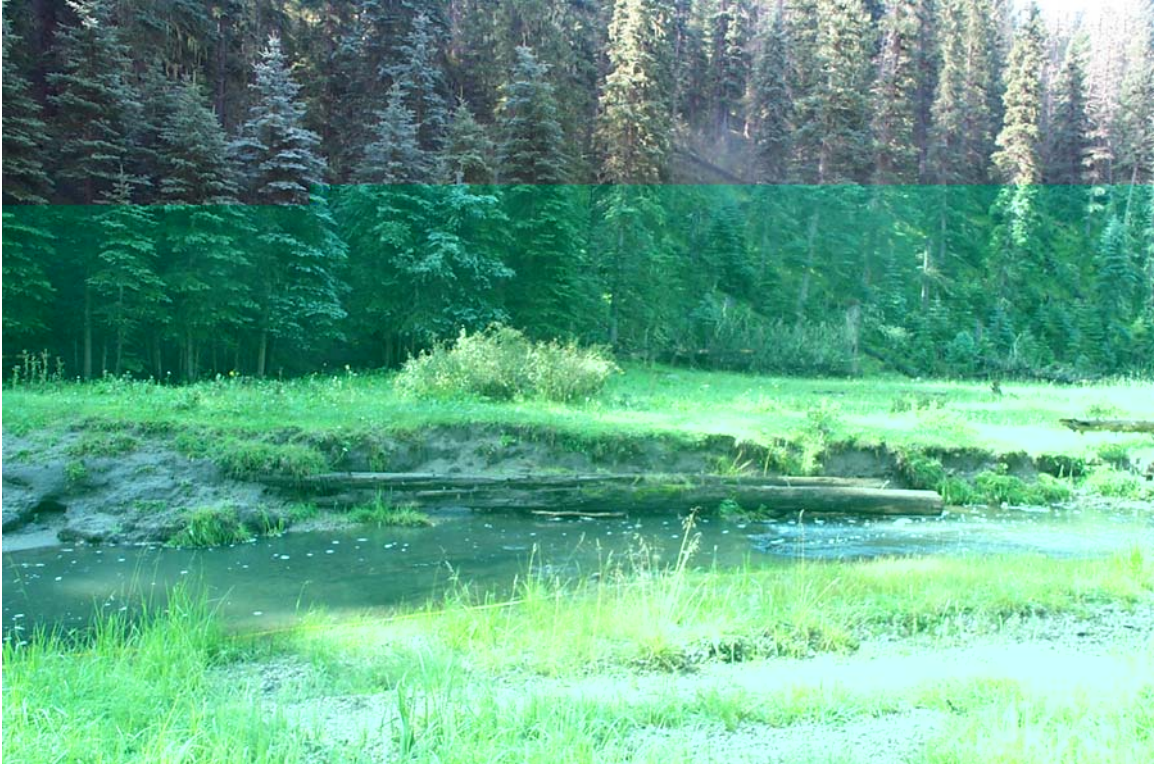
**Photo 6.** Reach 6, NSO 487, R197. LWD placements along bank. Note bank instability.

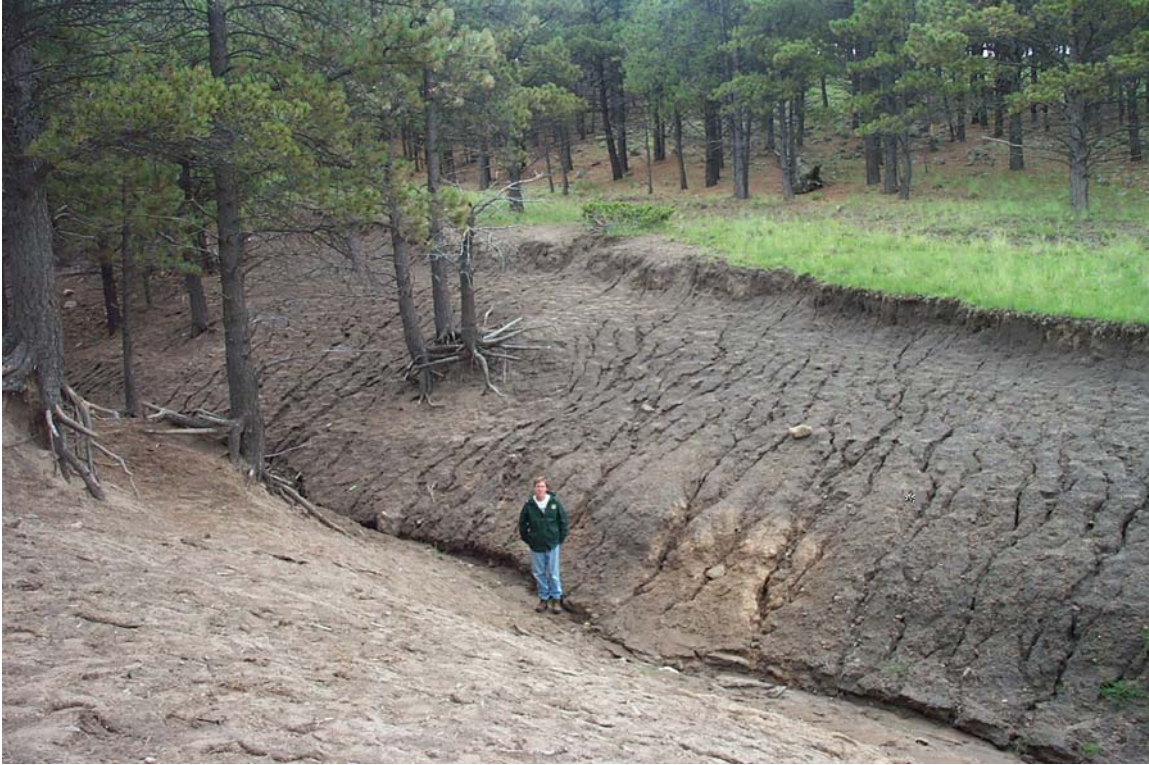
The East Fork Jemez River Watershed has an extensive road system. There are approximately 8.8 miles of road per square mile throughout the entire watershed. This is well above the US Fish and Wildlife Service recommended amount of less than 2.5 miles per square mile. The majority of the roads throughout the watershed fall in the VCNP, where there are approximately 10 miles of road per square mile. Many of the roads located in the watershed are old roads that are not currently in use or maintained. These unmaintained roads are sources of extensive sediment delivery in the East Fork Jemez watershed. During rain events, roads gully or wash out, inputting sediment into the stream. The road system on the VCNP is a major concern. Many of the current roads are poorly designed, as most roads are constructed below grade causing rain water to collect on the roads, increasing erosion (USFS Report on Watershed Concerns Summer of 2001). The roads in the VCNP are increasing the amount of fine sediments in the stream. The road system outside of the VCNP is much less extensive. There was no evidence of increased sediment loads from the road system outside of the VCNP.

**Photo 7.** Valles Caldera National Preserve. Gully formed between two logging roads. Notice heavy erosion and exposed tree roots.

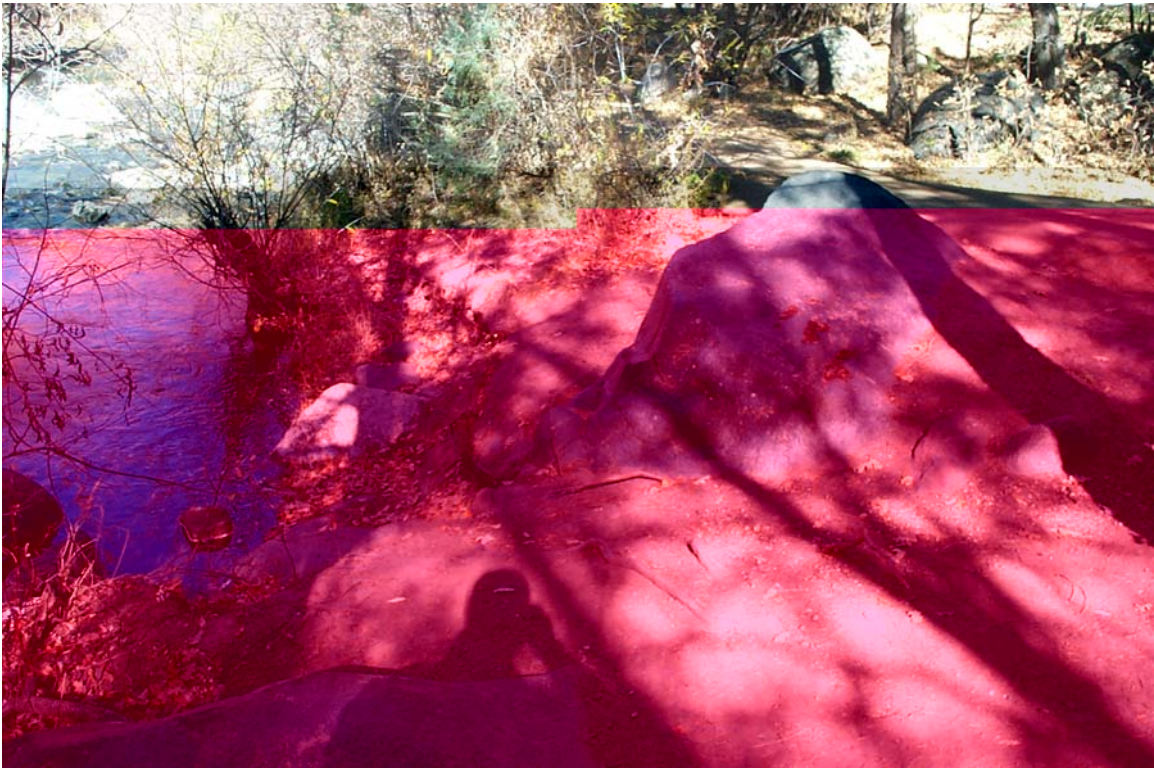
**Photo 9.** Reach 1 NSO 1. Streambank in a heavy recreational use area. Soil compaction caused by dispersed trail use along the East Fork Jemez River near Battleship Rock.

The heavy use of these areas has degraded riparian areas, as well as the stream itself. The numerous dispersed trails, especially near the river, have created sediment inputs to the stream. The trails have also caused soil compaction, which prevents riparian vegetation from re-establishing in these areas as well as stream widening. Many of the dispersed campsites can be found in the floodplain, and have created similar problems to the riparian vegetation. These areas have been totally “browned out” (no vegetation in the campsites due to soil compaction).

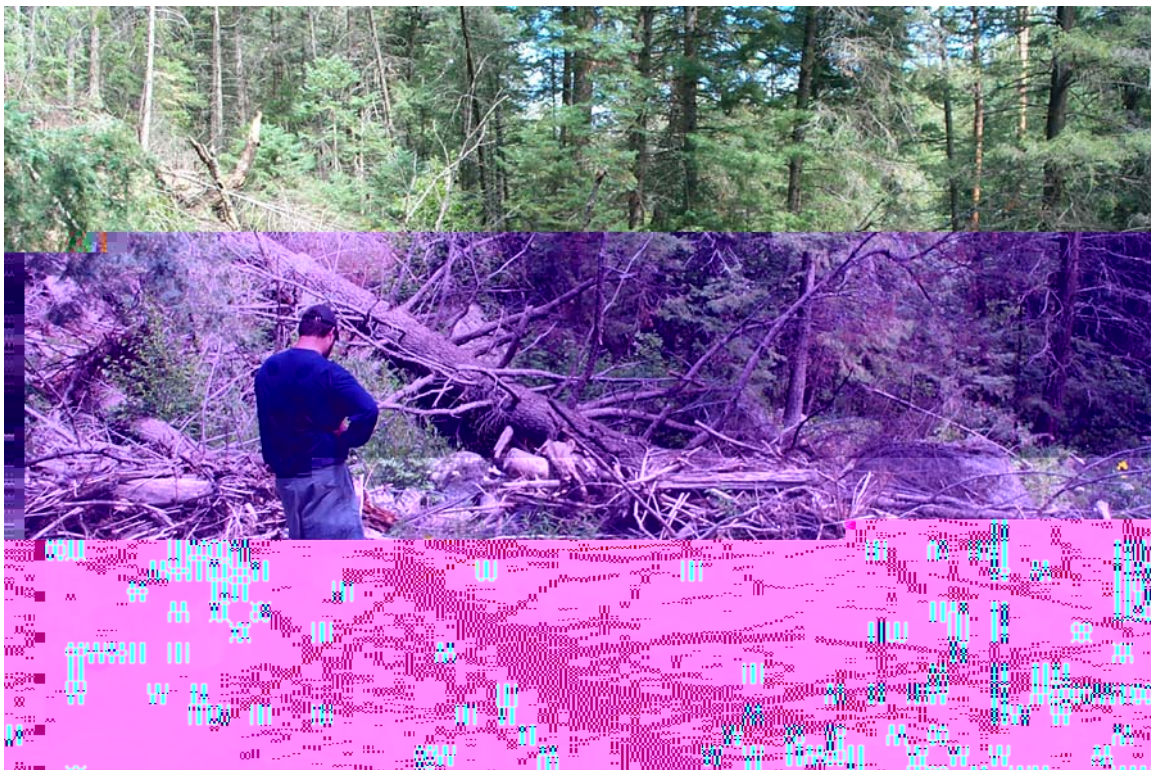
**Photo 13.** Reach 2. Recently created log jam in the East Fork Jemez River. Notice the gravels beginning to pile up behind the LWD. This was located in a steep section of the river, where it was acting to aggrade the channel.

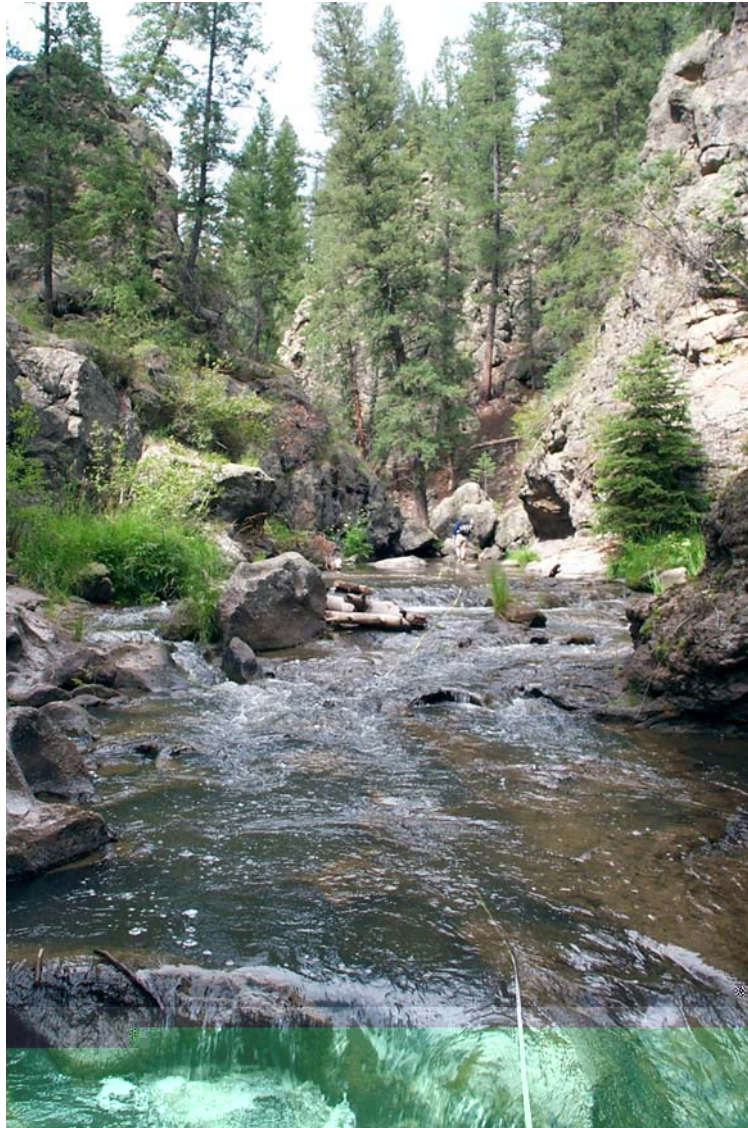
**Photo 14.** Reach 3. Typical riffle from this reach. Notice the bedrock substrate, riparian grasses, and deep eroded potholes in the bedrock.

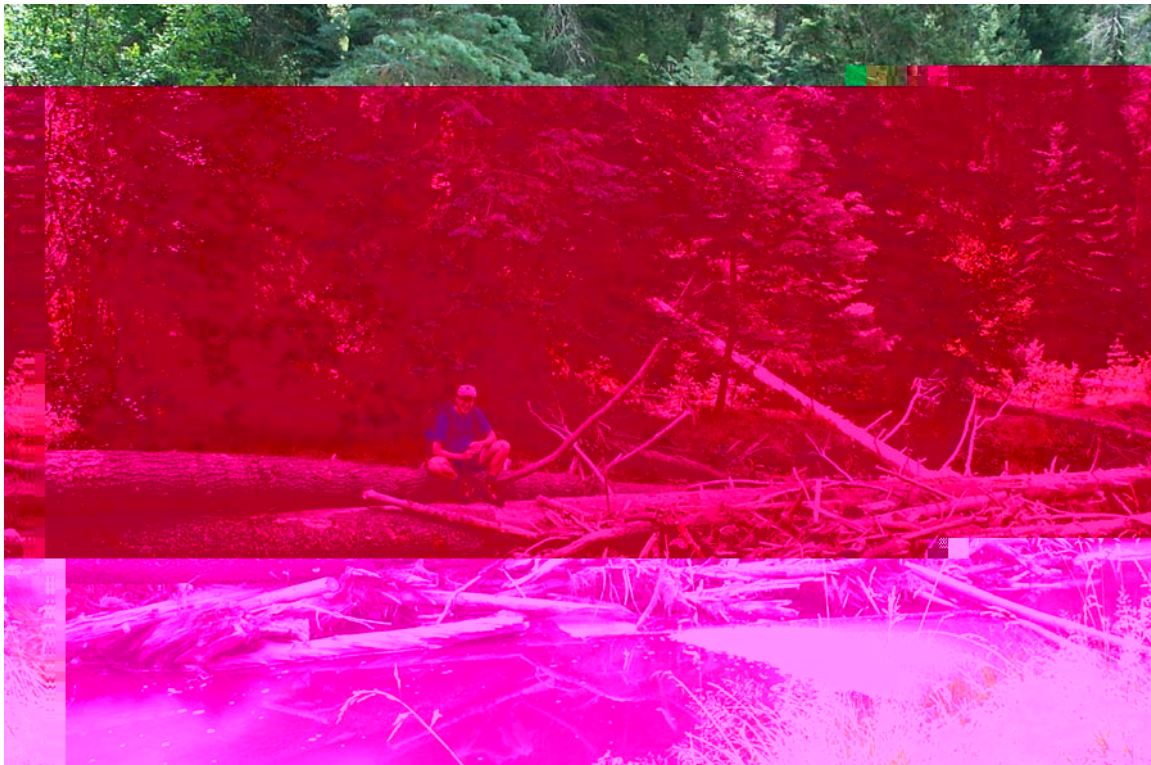
**Photo 15.** Reach 4, NSO 249, R106. One of the logjams recorded in Reach 4. Notice the lack of woody riparian species along the banks.

Dispersed campsites should also be closed off, and rehabilitated, and this section of stream should be managed as day use only. Riparian vegetation should be reestablished to restore proper functions to the riparian ecosystem. An educational sign should be

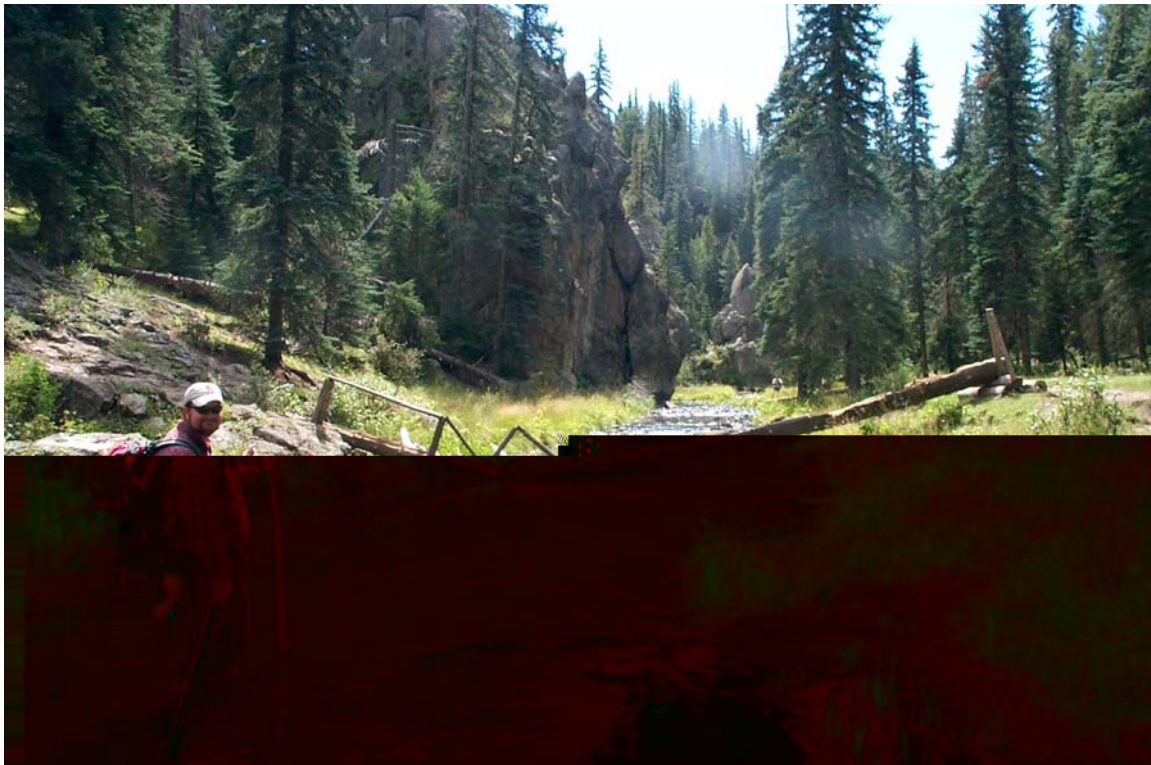
**Photo 18.** Reach 6, NSO 449, R180. One of the 7 log bridges encountered in this reach. Notice the large amounts of sand present and the lack of woody riparian vegetation.

The dispersed campsites should be rehabilitated as well. There were many areas where the campsites had removed all vegetation in these areas, further adding sediment to the stream. Rehabilitating some of the sites, and informing the public as to why the sites

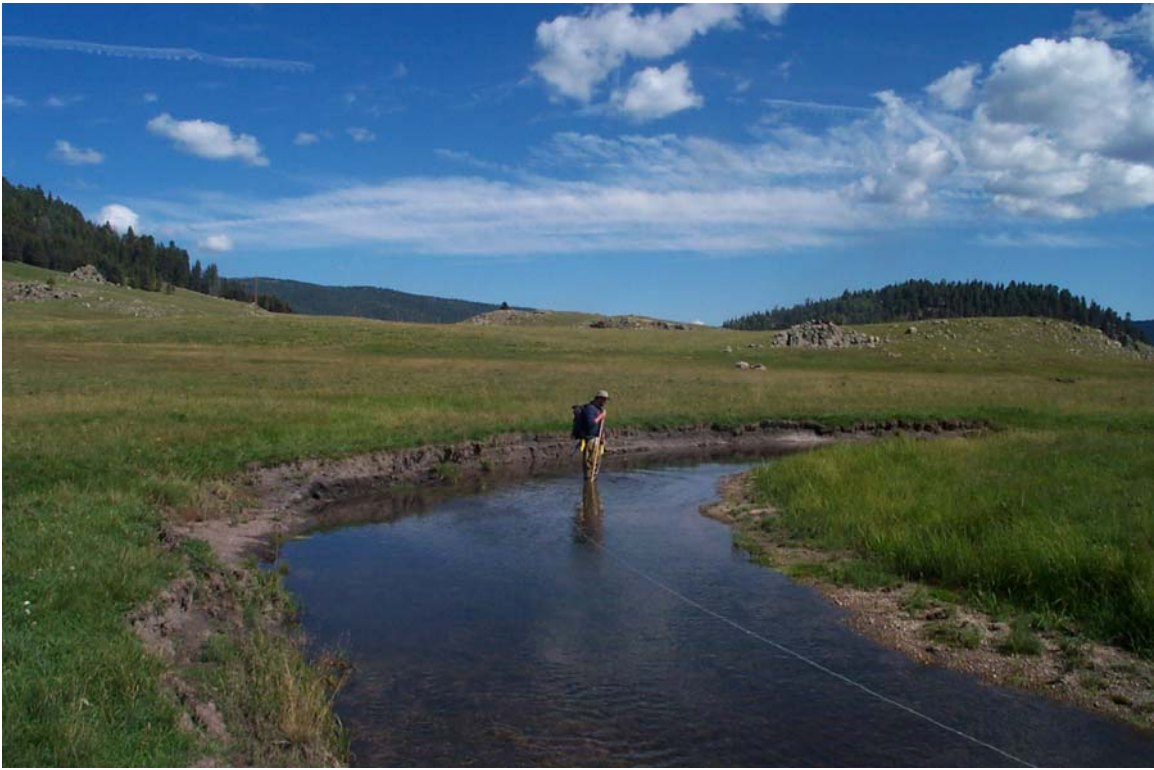
**Photo 19.** Reach 8 NSO 509. Heavy bank erosion on the left bank (outside of the bend). Notice how shallow and wide this area is, as well as large quantities of fine sediments.

Native riparian species could be planted in the riparian area. The planted species could be placed in protective tubes to prevent browsing from elk and cattle. On Comanche Creek, in the Valle Vidal, willows have come back naturally in areas that are protected from grazing. However, a range rider would be necessary to keep cattle from browsing heavily upon the riparian vegetation. A healthy riparian area is necessary to keep water temperatures low, as well as stabilizing the stream banks. A healthy riparian area would also provide water storage, and an allocthonous source of nutrients for the stream invertebrates. It is recommended to burn some of these areas to promote growth of native species that have a dormant seed bank in the soil. Burning the grass areas would assist in removing non-native species, which currently persist in some areas.

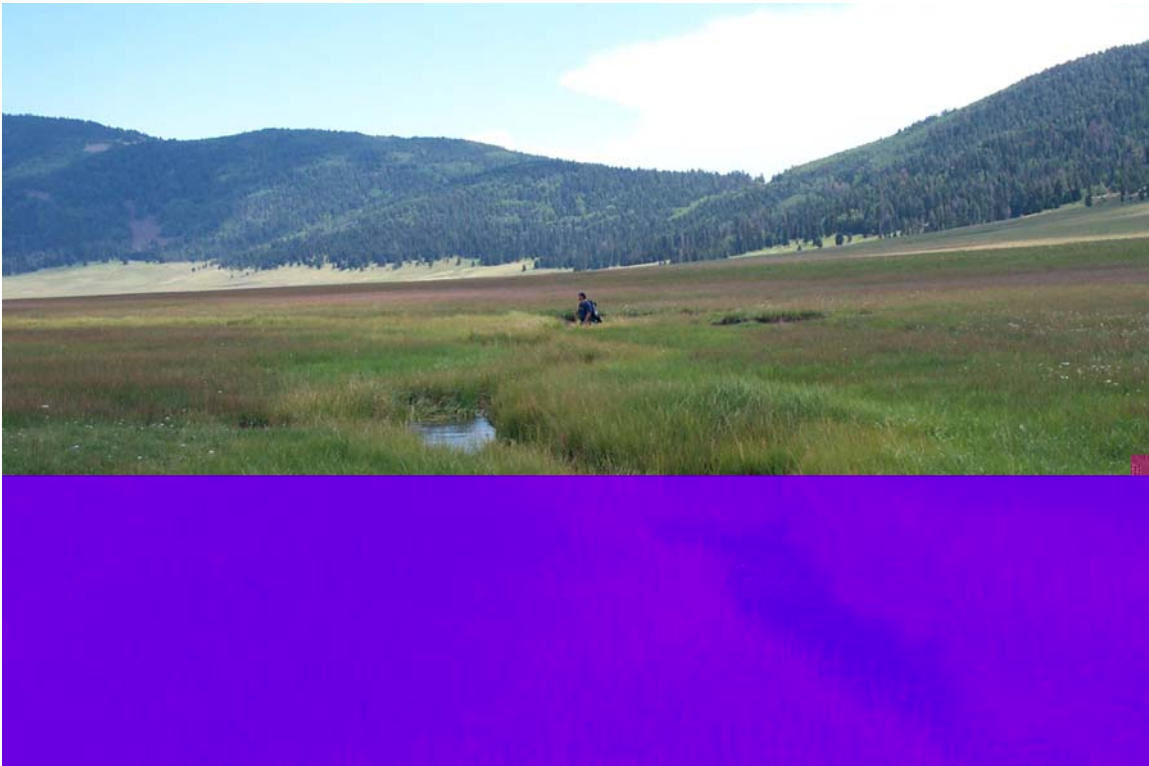
**Photo 21.** Reach 8, NSO 538, R. Typical habitat throughout Reach 8. Notice lack of woody riparian species.

Native riparian species could be planted in the riparian area. The planted species could be placed in protective tubes to prevent browsing from elk and cattle. On Comanche Creek, in the Valle Vidal, willows have come back naturally in areas that are protected from grazing. However, a range rider would be necessary to keep cattle from browsing heavily upon the riparian vegetation. A healthy riparian area is necessary to keep water temperatures low, as well as stabilizing the stream banks. A healthy riparian area would also provide water storage, and an allocthonous source of nutrients for the stream invertebrates. It is recommended to burn some of these areas to promote growth of native species that have a dormant seed bank in the soil. Burning the grass areas would assist in removing non-native species, which currently persist in some areas.
